بررسی آسیب پذیری و نحوه مقاوم سازی سازه های موجود در سیستم های حمل و نقل هوایی

سمینار درس مقاوم سازی لرزه ای سازه های خاص

ارائه دهنده : امید عزیزپور

پژوهشگاه بین المللی زلزله شناسی و مهندسی زلزله

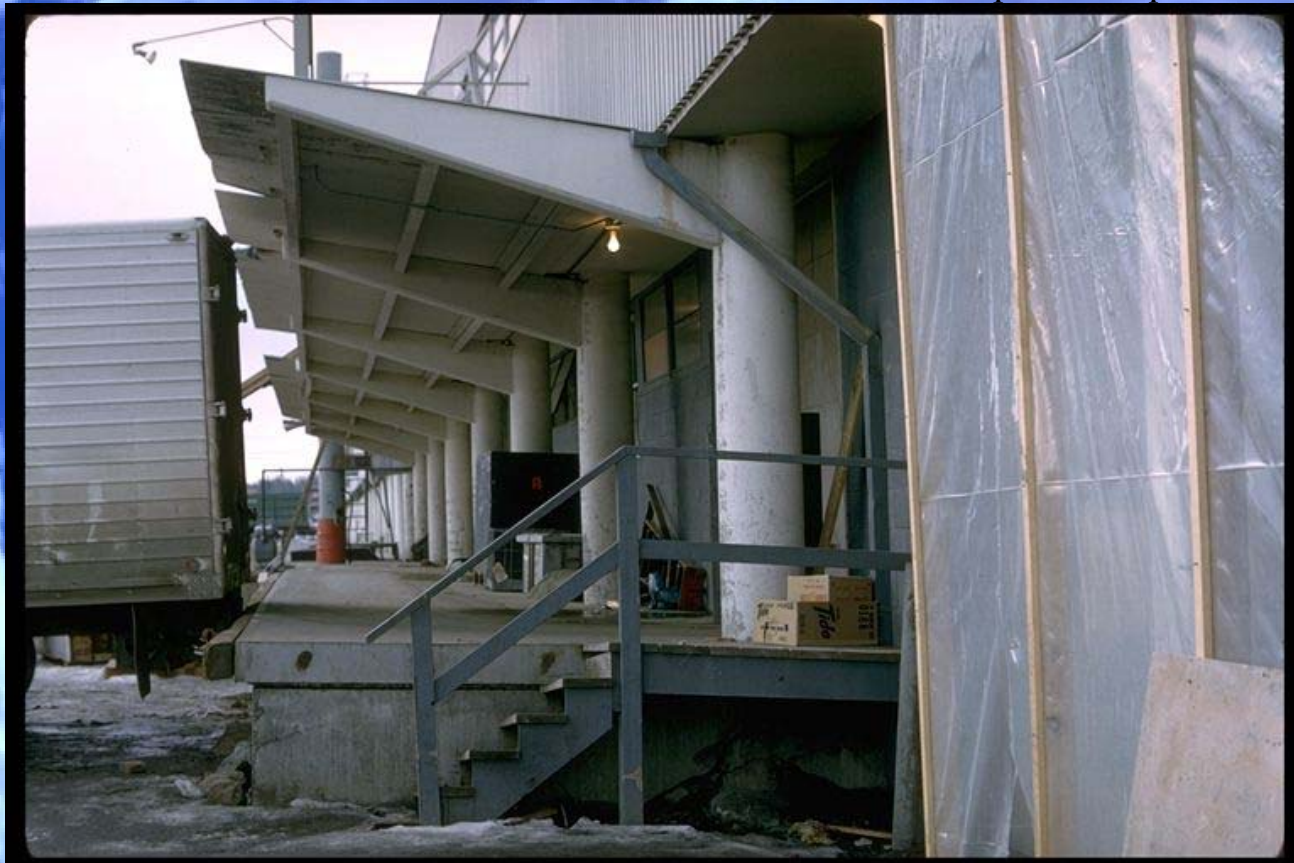
Note settlement of dock floor. Not known how much was pre-earthquake.

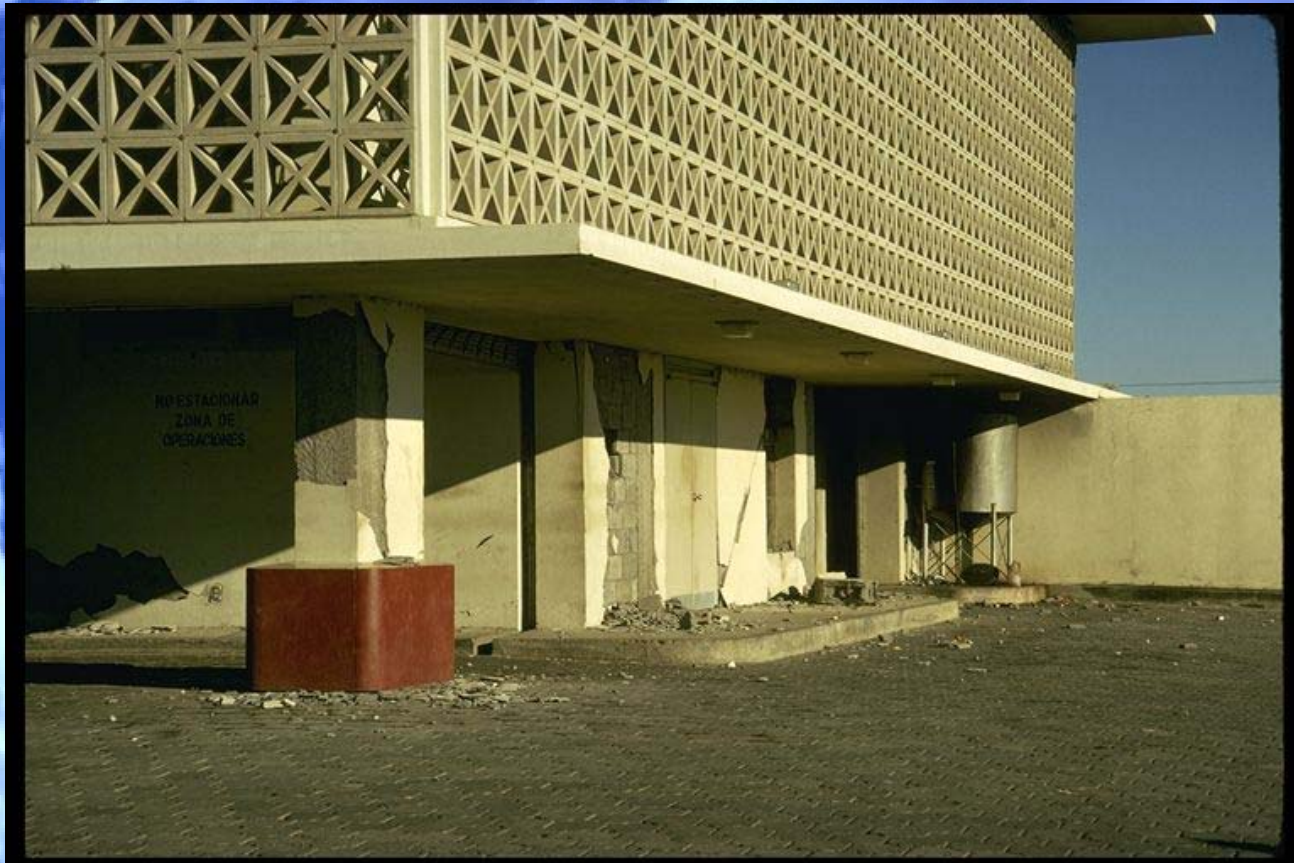
South end of Terminal Building

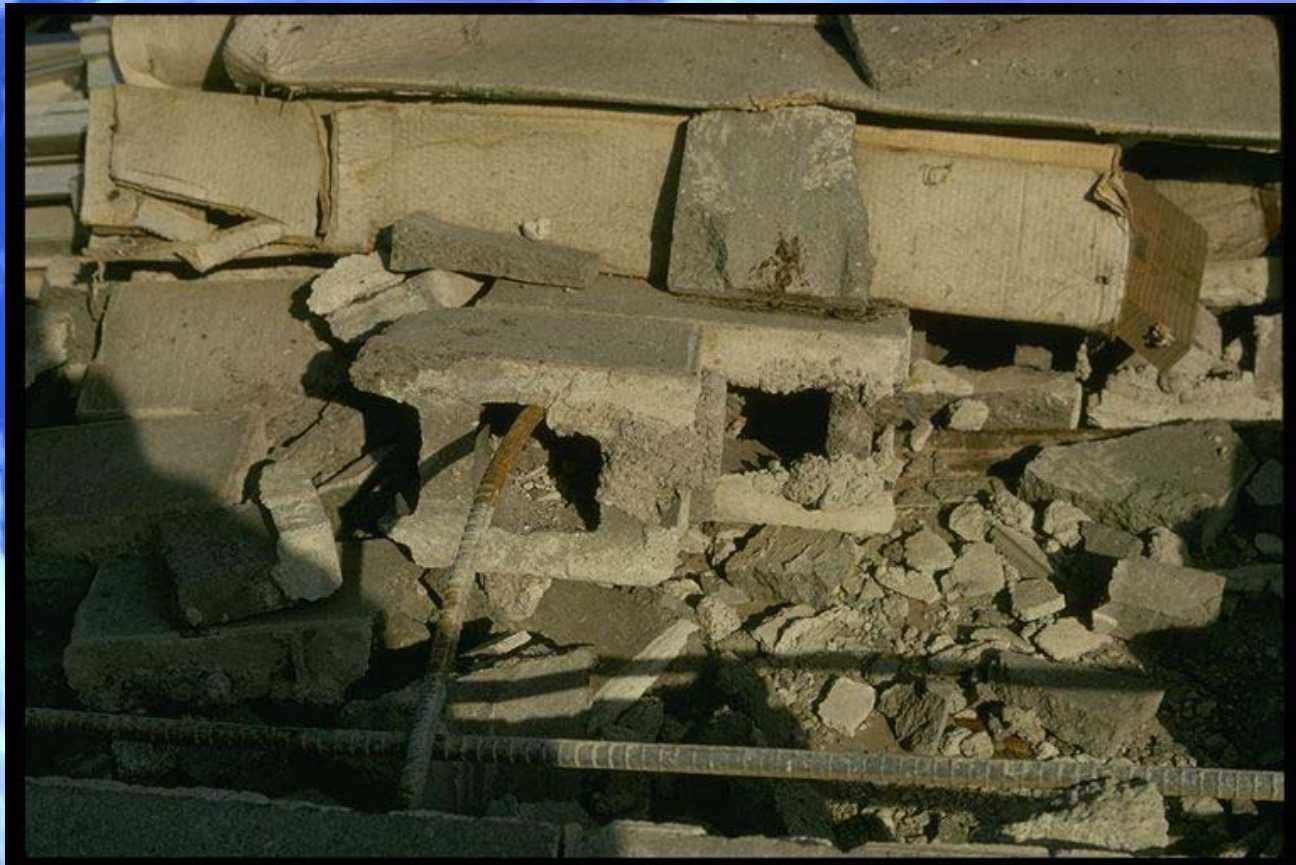
Hollow concrete block cell with no grout. Gay Airways building

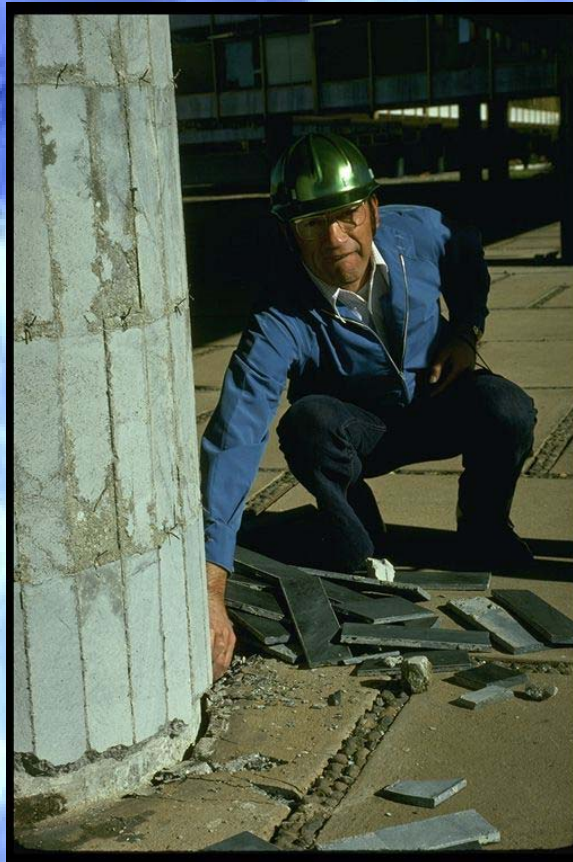
International Airport. Column damage in South "finger." Detail of S5112

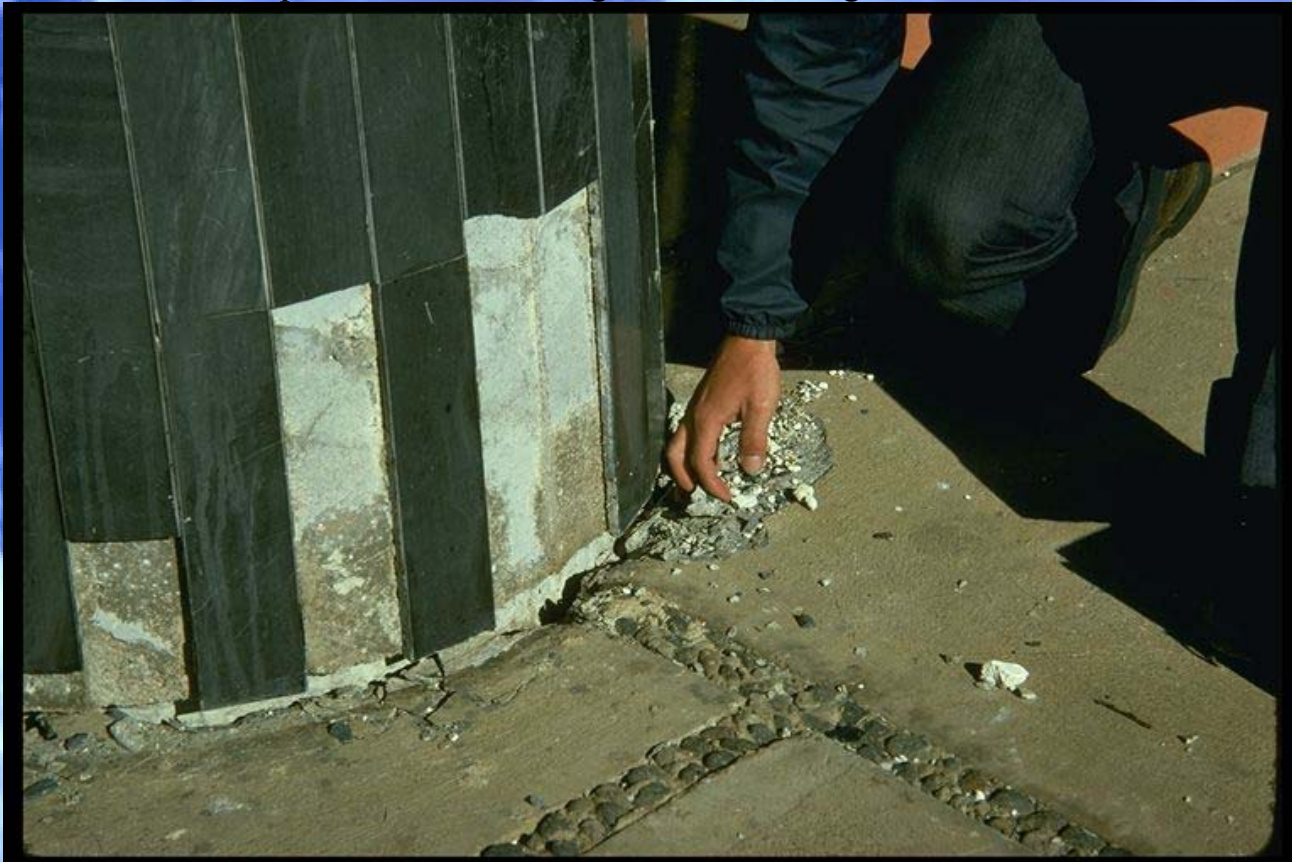
International Airport. Column damage in South "finger." Shows detail of S5112

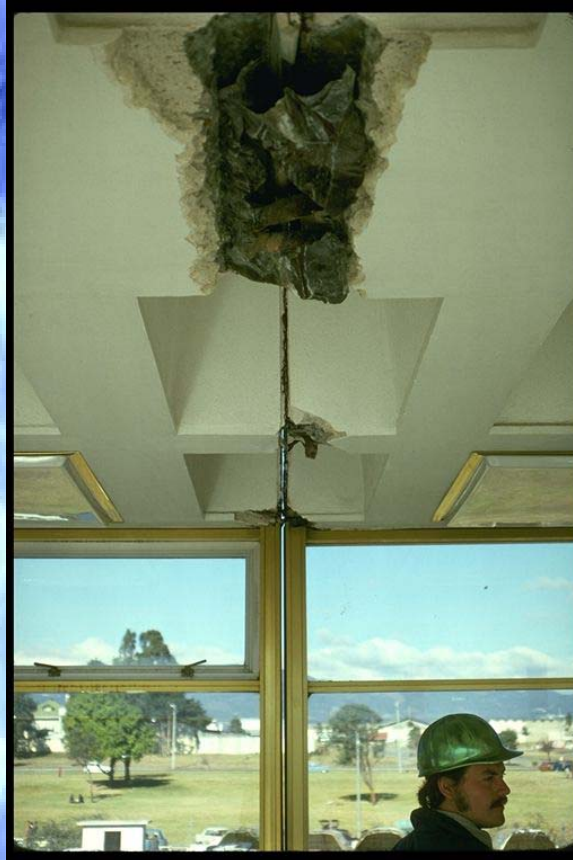
International Airport. Structural damage (?) in South "finger."

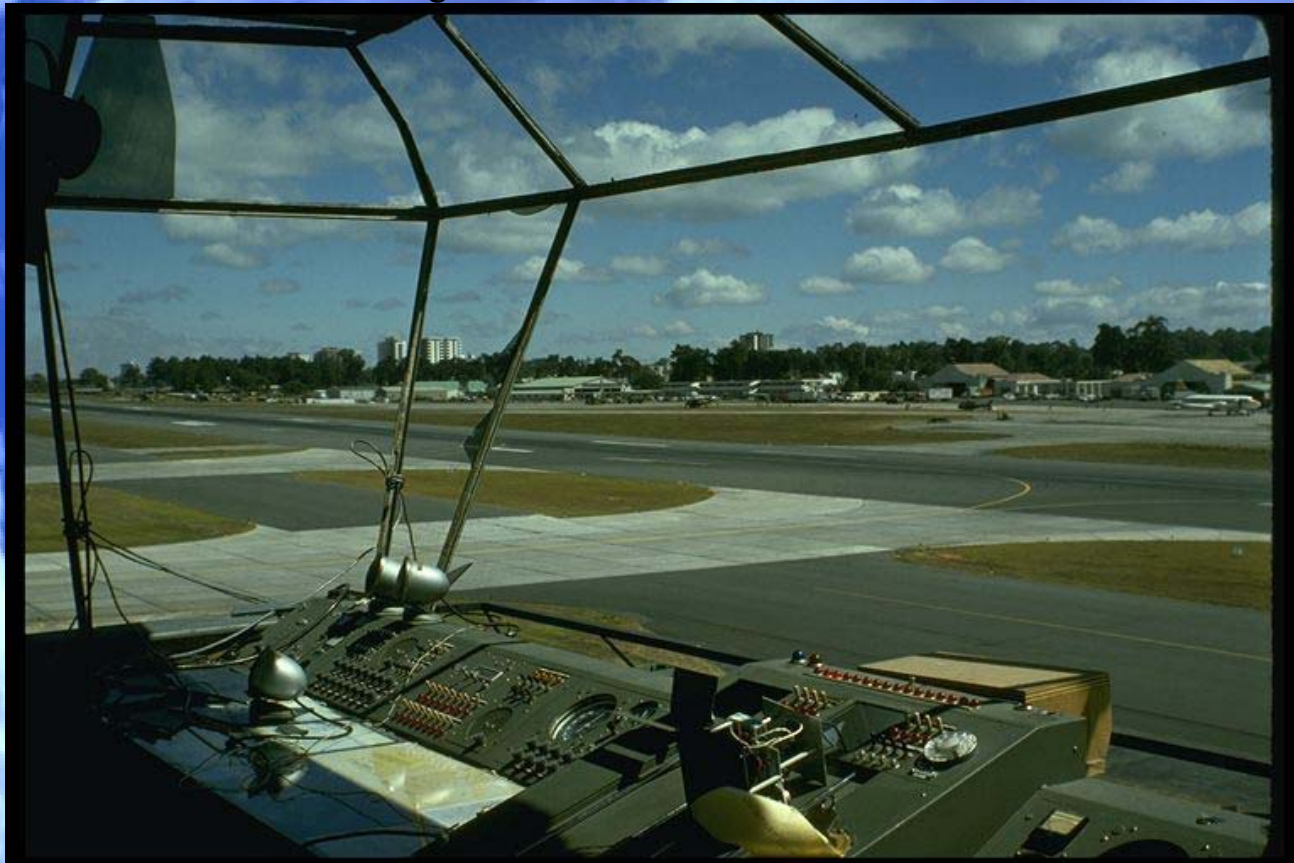
No glass in control tower windows.

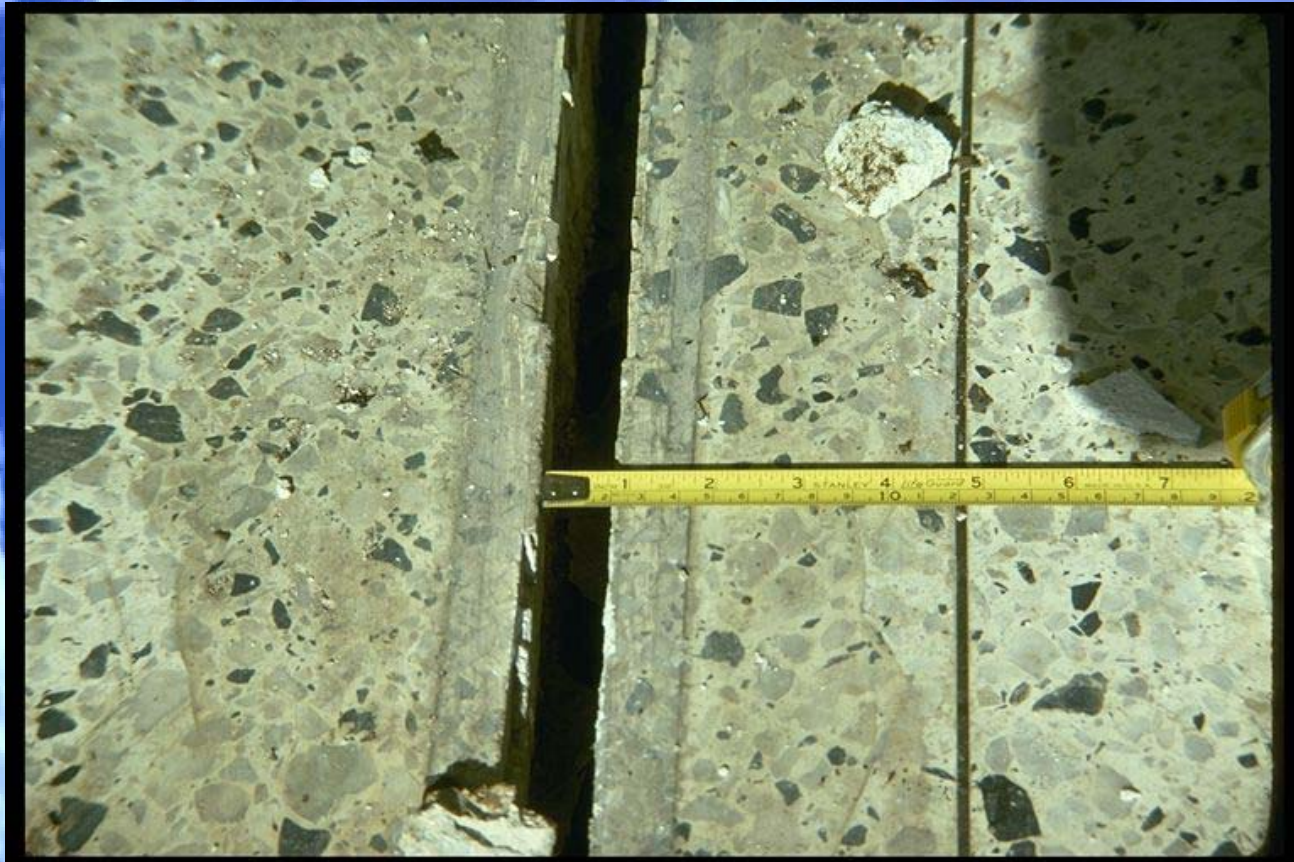
International Airport. South "finger". Separation in second floor at structural separation

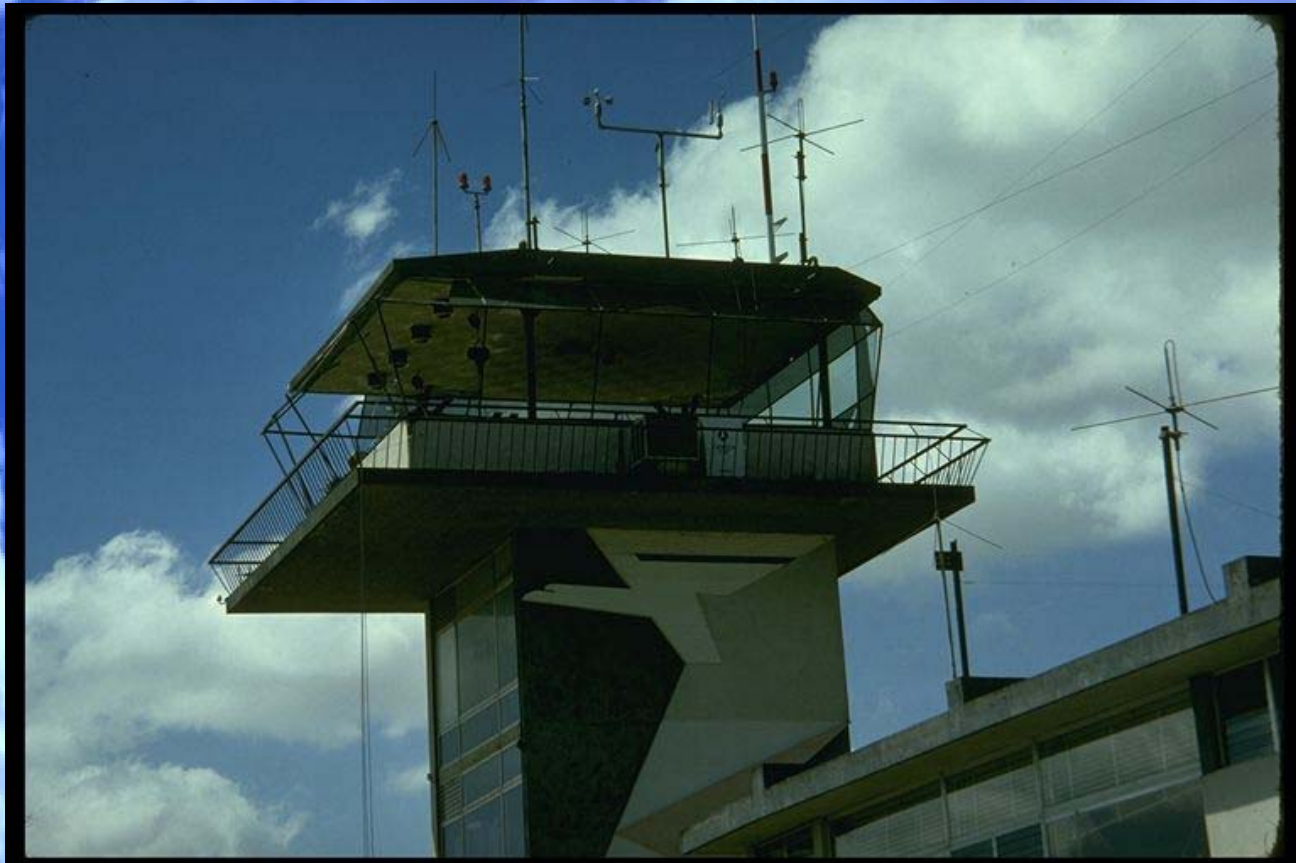
Control tower had minimum damage, principally glass.

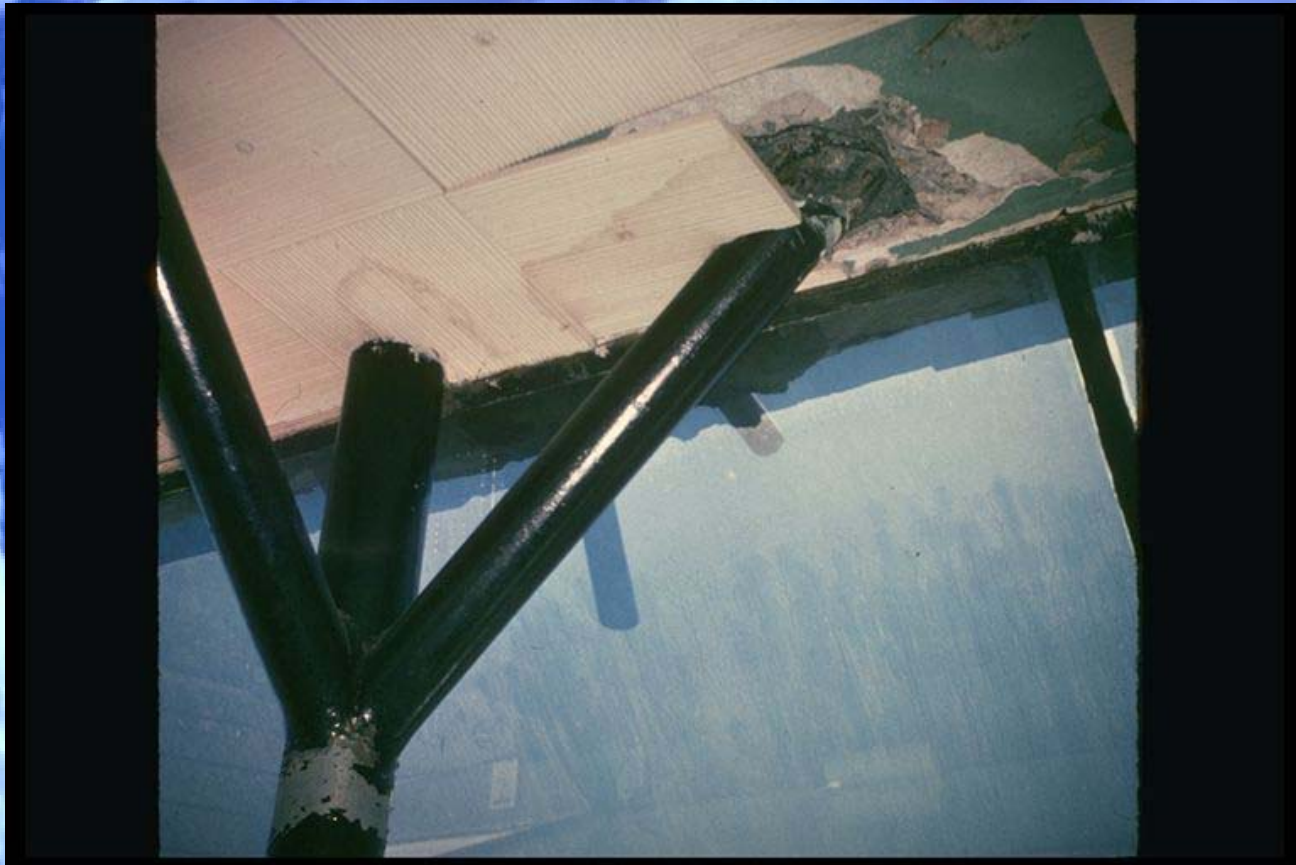
Control tower had minimum damage, principally glass. Shows bracing in top story pulled ou

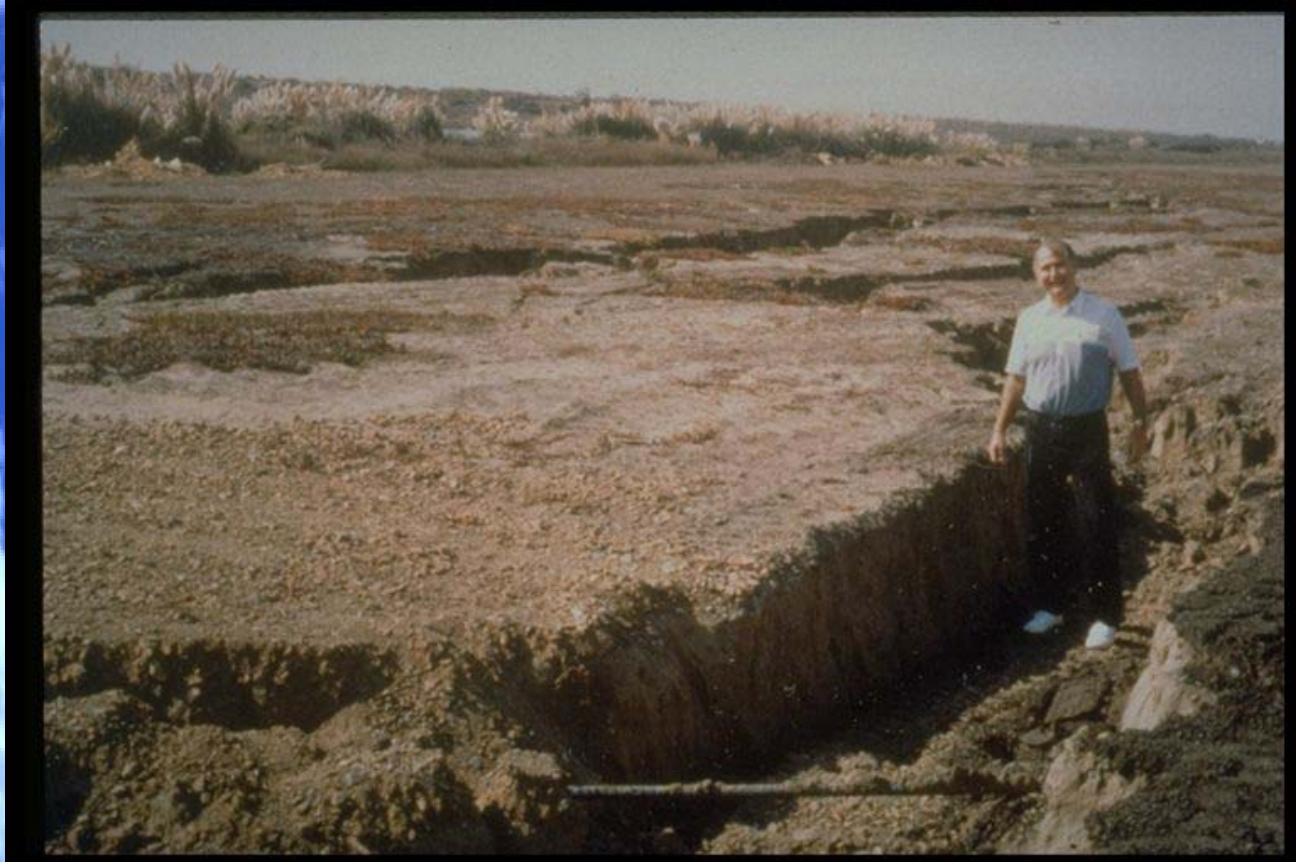
Major fissures, grabens, and sand boils near the northwest end of the main runway

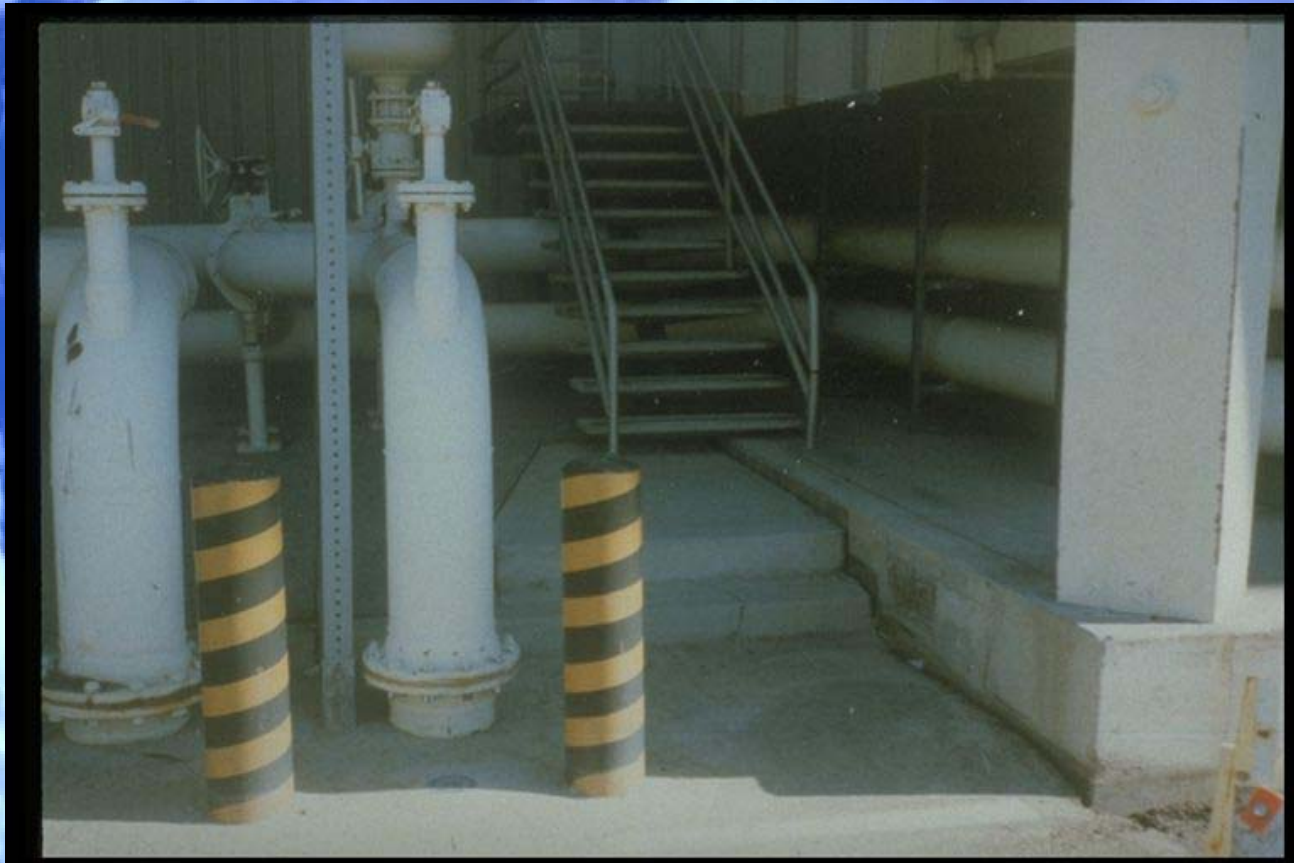
Settlement adjacent to main terminal building.

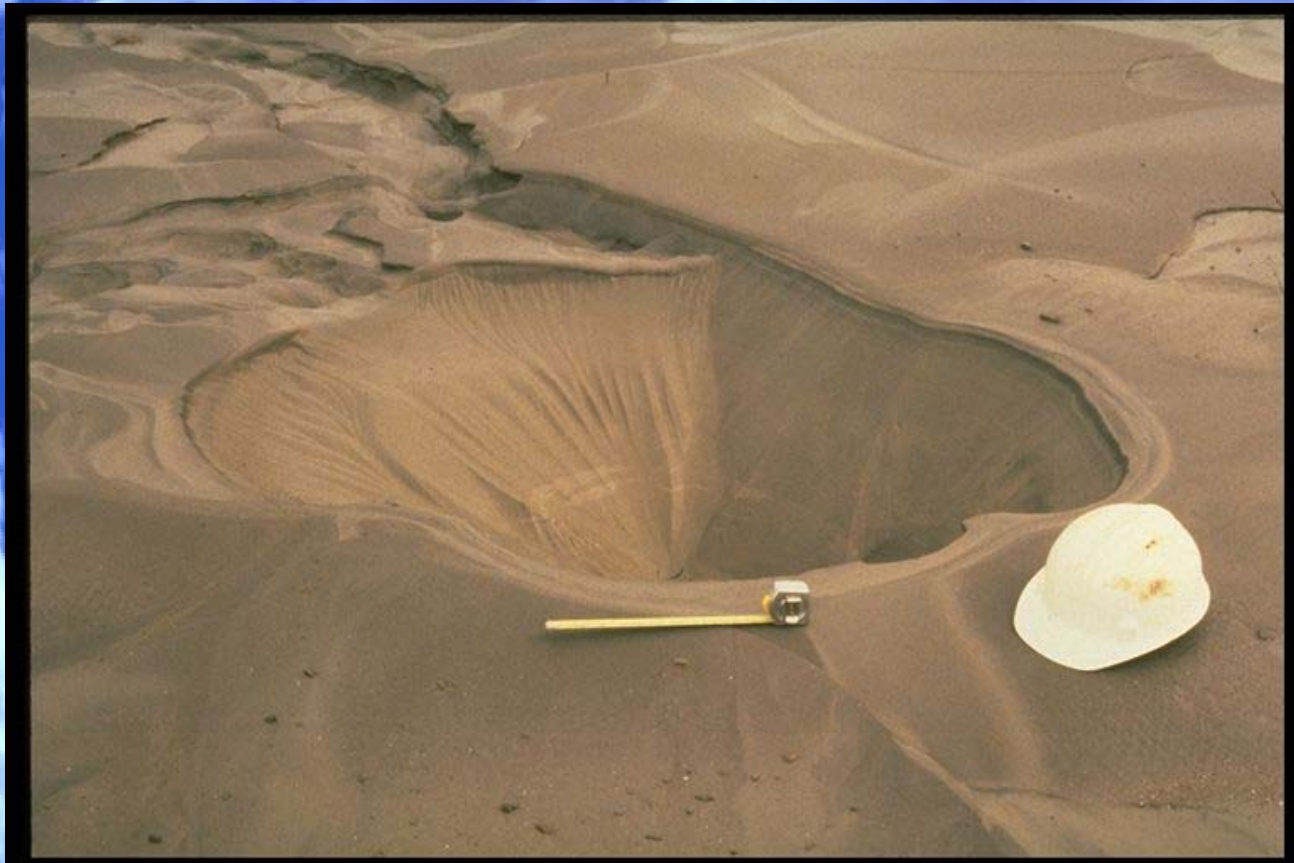
Large sand boil.

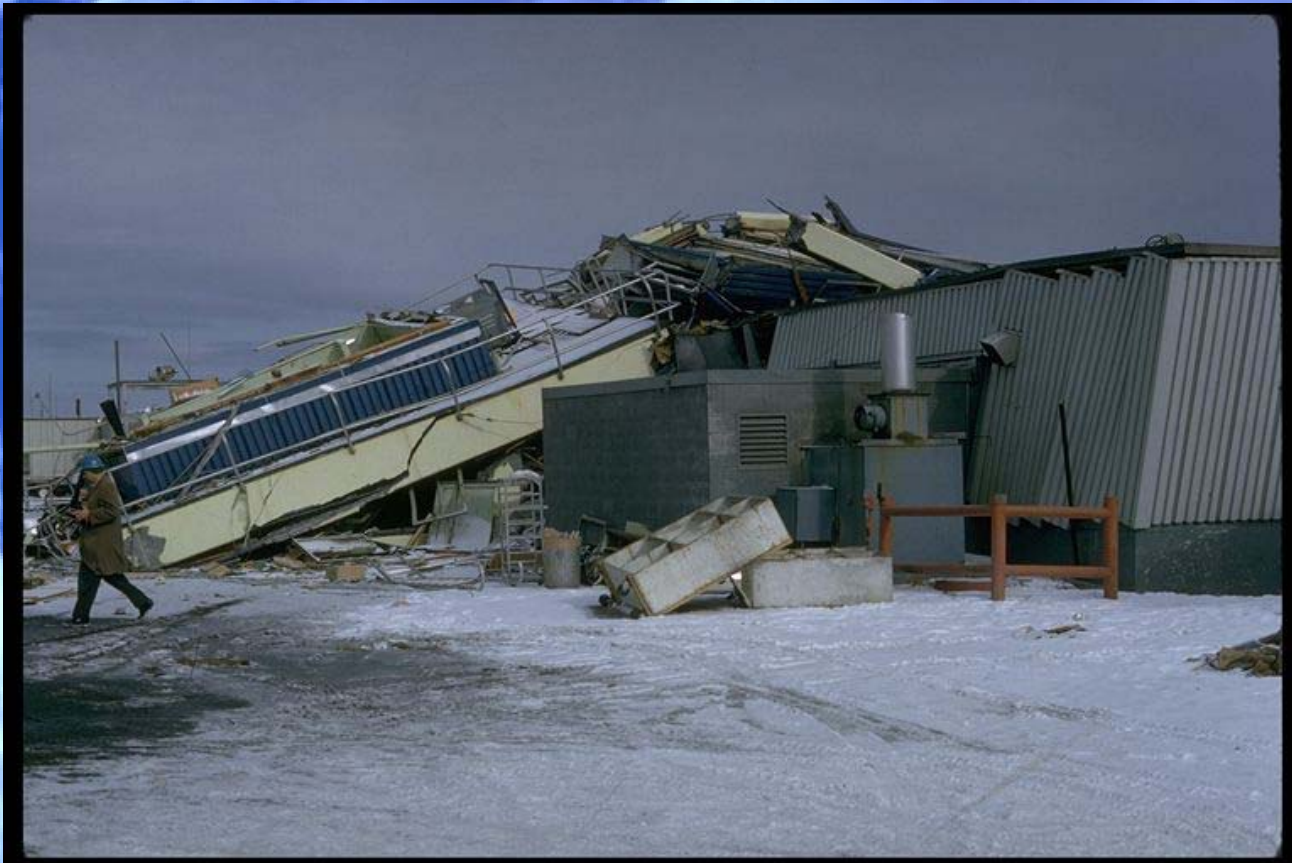
Reinforced concrete frame, with metal panel walls. This tower was damaged previously in the 1954

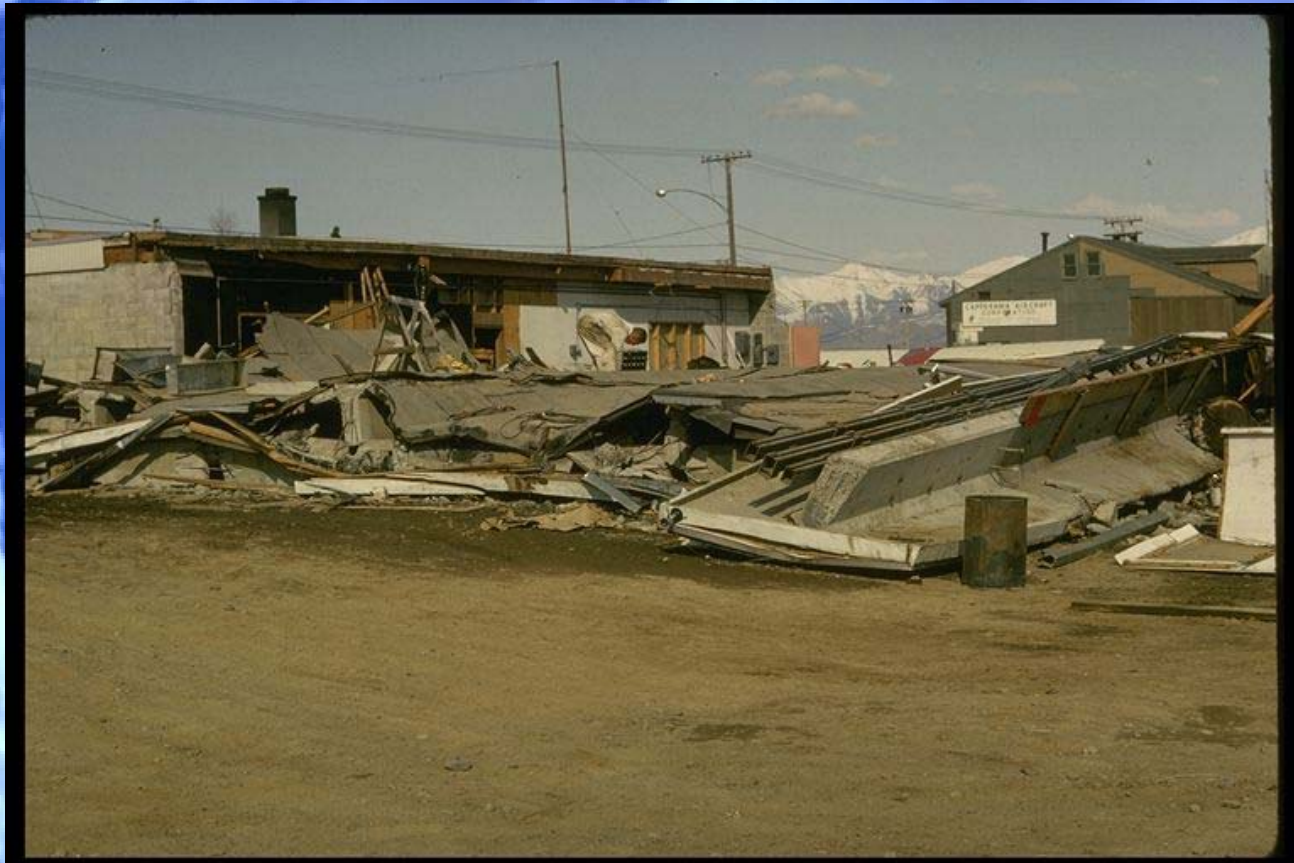
Rear of building, looking northeast. Precast "T" beams on hollow concrete block walls
